Saluda Instream Flow Study

Final notes from site reconnaissance 11/28/06

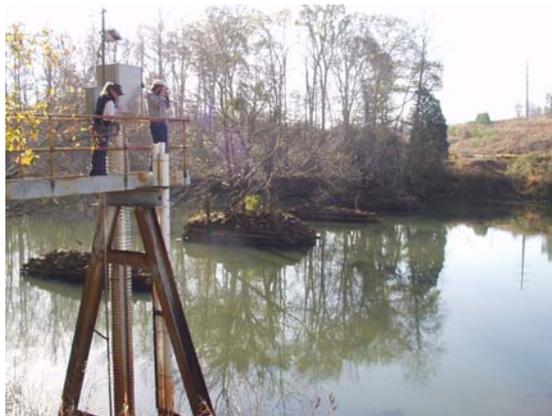
Photo 1. Run habitat and USGS gage below Lake Murray outlet

USGS Gage site. This site is located in Reach 1 above the confluence with the overflow channel, It features steep vegetated banks, and laminar flow, and bank width of approximately 100 ft.. Channel bottom appeared relatively even with fines and scattered object cover. Bridge piers are evident just below the gaging station (Photo 1). Based on the mesohabitat definitions, the group agreed that this site represented a run at this flow.

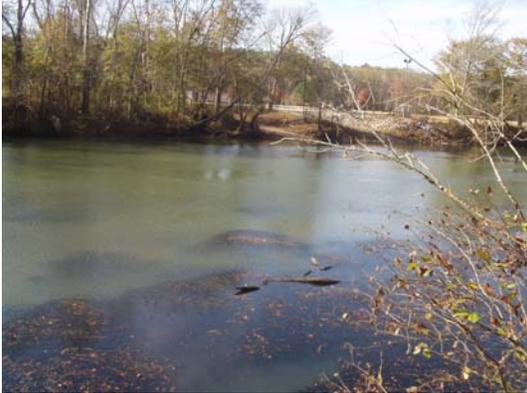
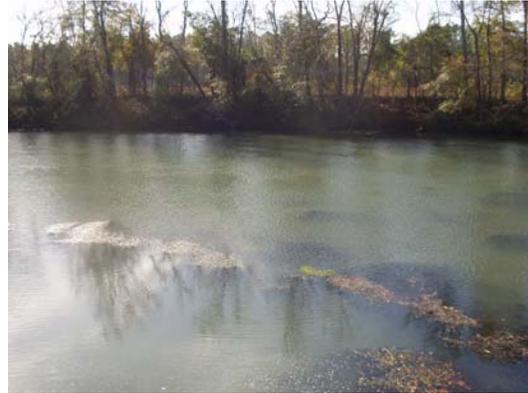
Photos 2 and 3. Views of run mesohabitat and aquatic vegetation at Saluda Shoals.

Saluda Shoals. The team investigated the river channel between the Saluda Shoals Park boat ramp downstream to Corley’s Island. One part of the area is composed of runs that are fairly uniform, similar in width, bank profile, and gradient to those at the USGS gage site, but with more pronounced aquatic vegetation beds, some of which are anchored to large substrates (Photos 2 and 3).

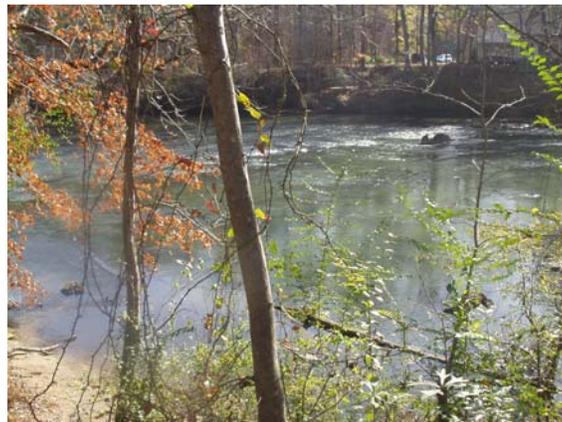
Photo 4. View of riffle in Saluda Shoals area

The team also identified areas that appear to be riverine pools in this segment. There are also a few scattered riffles exposed at this flow, comprised primarily of exposed large boulders and possible tips of some bedrock surrounded by fines such as sand and small gravels (Photo 4). Rawls Creek joins the Saluda River in this segment and marks the beginning of Reach 2.

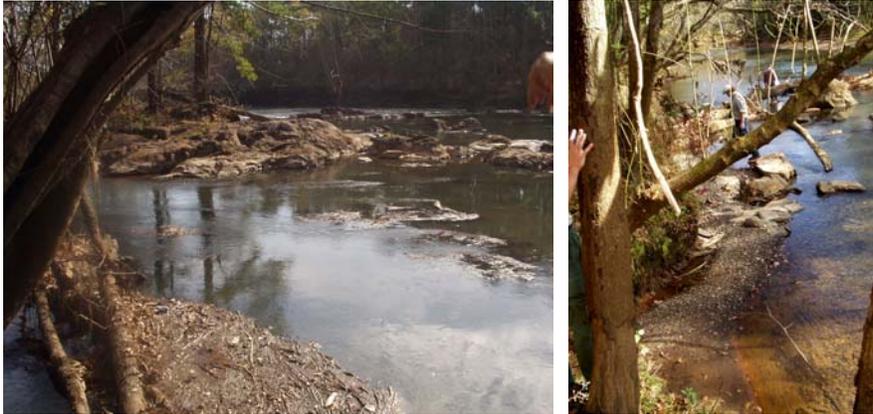
Photos 5 and 6. Upstream tip of Corley's Island with shoal in main channel (*distant in the photo*), and object cover and substrates in upper portion of side channel.

Corley’s Island is located below this area. The island is tied to a pronounced ledge outcrop that forms a distinct shoal in the main channel and has a stable bedrock hydraulic control directing water into the side channel. The side channel is predominantly shallow run habitat, and was originally excavated as a canal, but has aggraded with ledge/boulder/woody debris in the upper segment of the side channel (Photos 5 and 6) giving way downstream to a uniform, open sandy and shallow channel with little object cover and fine substrates (Photo 7). A cross-channel has cut across the middle section of

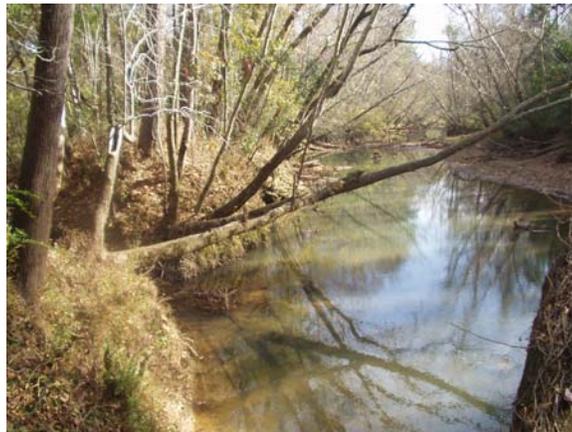
Photo 7. Lower portion of side channel at Corley's Island.

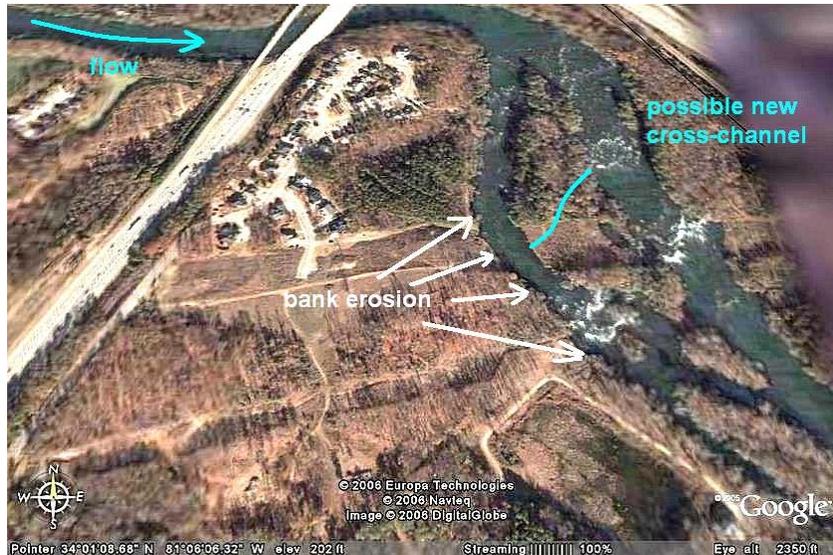
Photo 8. Oh Brother Rapids/Ocean Boulevard (image courtesy of Google Earth®).

Oh Brother Rapids/Ocean Boulevard. This site is located where the river begins to descend the fall line (upper end of Reach 3), which is the transition between Piedmont and Coastal Plain geomorphic provinces. Thus gradient and substrates are more pronounced than in the upstream sites. The group accessed the river via private property with a right of way provided by Trout Unlimited. This site is more hydraulically complex than upstream areas. An island forms two channels that descend through bedrock shoals, with the Oh Brother Rapids channel appearing to be the secondary, possibly newer channel. There is at least one cross-cutting channel traversing the main island, and braided areas below the larger main island. (Photo 8).

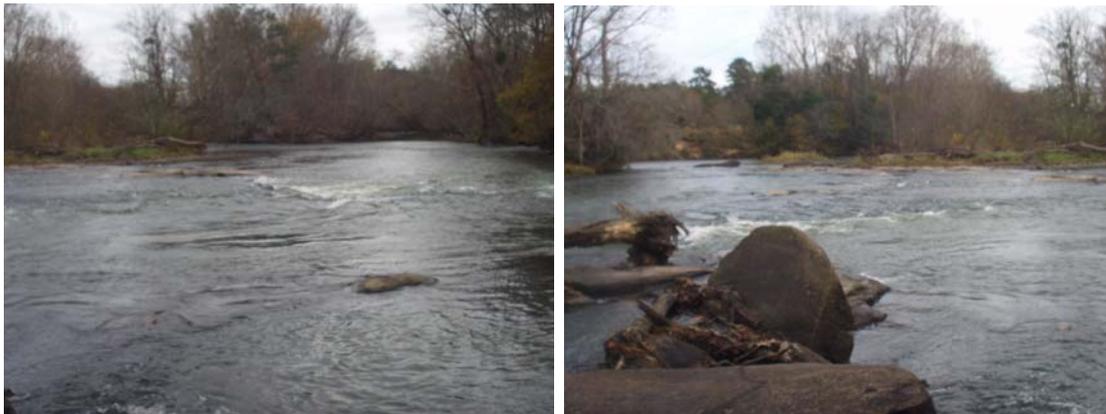
Photos 9 and 10. Oh Brother Rapids: Example of riffle/shoal/substrate and braided channels.

The Oh Brother Rapids area included well-defined examples of shoal, riffle, run and pool mesohabitats, and distinctly different (i.e. larger and more abundant larger substrates that provide object cover, eddies and holding areas for a variety of species and lifestages of interest to the TWC (Photos 9 and 10). There is also an area of active erosion along the right channel (looking downstream), suggesting that this channel is in a state of dynamic disequilibrium. The group viewed and discussed this, and recognized that this could be a

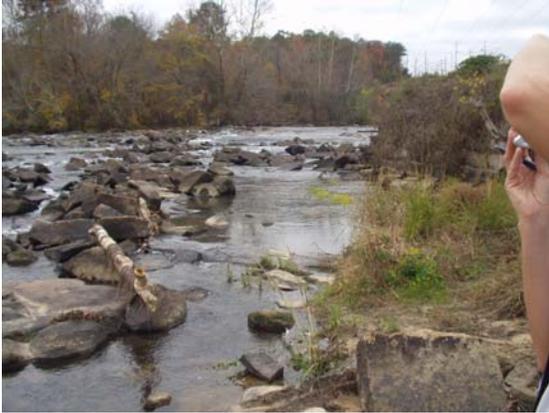
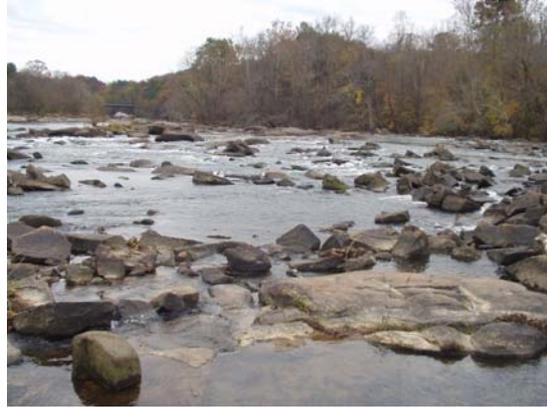
Photos 11 and 12. Millrace Rapids. Views looking upstream (Photo 11) and downstream (Photo 12).

Millrace Rapids. This marks the upstream boundary of Reach 4. The river channel width increases at this point, and there are multiple braids and interstitial flow passing between and under large boulder and broken rubble remains of a former masonry dam (Photos 11 and 12). It was noted that a plunge-pool exists at the toe of the rapids, and the team agreed that an empirical rather than PHABSIM-model approach would be preferred to characterize hydraulics at this location. Kayakers were observed navigating the rapids at this flow.

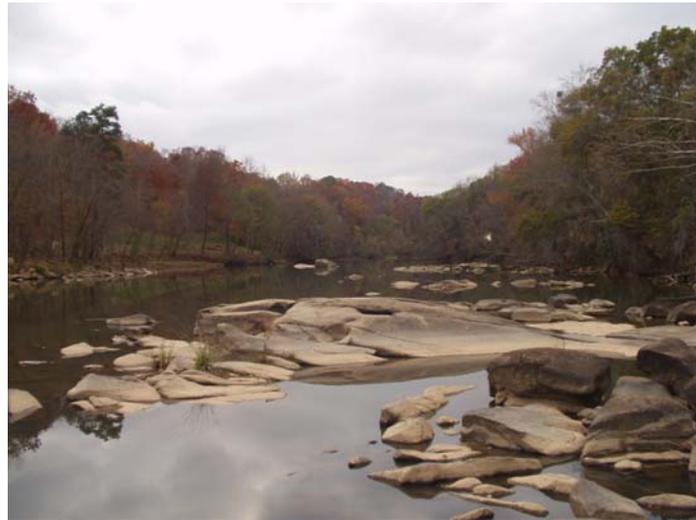
Photo 13. Pool and object cover area looking upstream at Riverbanks Zoo site.

Riverbanks Zoo. The group viewed a pool/run/rapids complex at the downstream end of the Riverbanks Zoo property. This area featured large object cover (decomposed boulder and ledge substrates dominated), and a large pool that is clearly ledge-controlled. The team viewed the upper segment of Shandon Rapids, which appears to be shoal habitat that descend to the Broad River through a braided channel with large boulder substrates (photos 13 and 14).

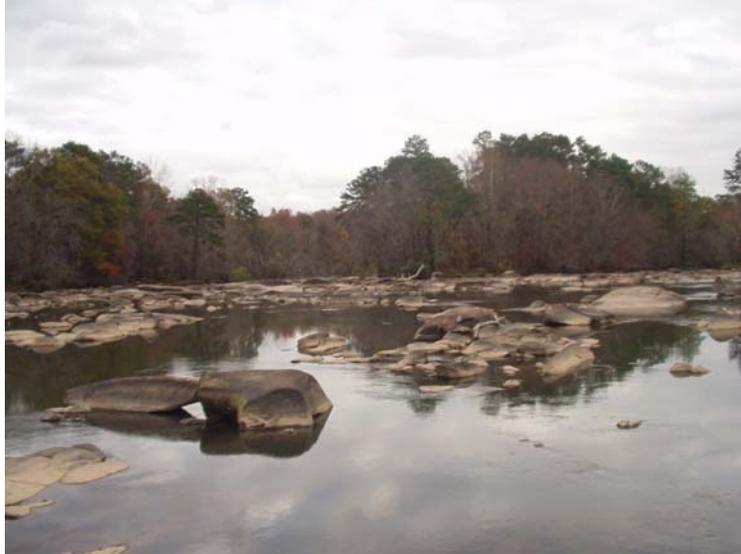
Photo 14. View looking downstream from Riverbanks Zoo, across pool to the crest of Shandon Rapids. Island in center (*indicated by tall trees*) creates steep gradient braided channels.
